The Walls of Eupalinos Aqueduct, Samos Island, Greece. Description, Pathology and Proposed Restoration Measures

*Research Paper*

THE WALLS OF EUPALINOS AQUEDUCT, SAMOS ISLAND, GREECE. DESCRIPTION, PATHOLOGY AND PROPOSED RESTORATION MEASURES

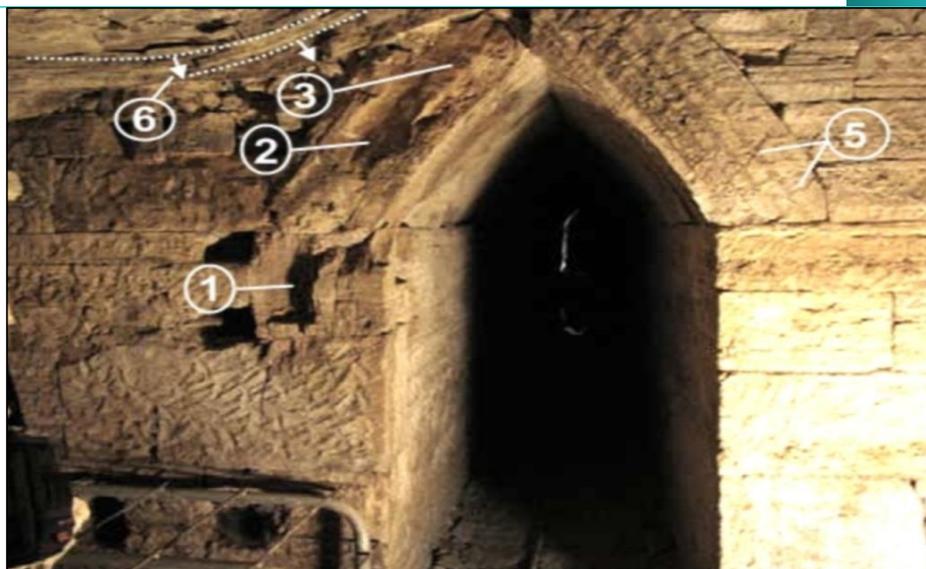
Ch **0+064** is the starting point of the Archaic lining. At this point the lining suffers a minor but interesting damage: A few pieces/flakes have been detached from the front surface of the roof's arch stone i.e. at points 2 and 3 of Figure 8 and from its supportive stone i.e. at point 1 of Figure 8.

Fig. 8: Flakes detached from the front surface of the roof arch stones at points 1, 2 and 3. Two new cracks have been identified in the right roof slab at point 5. Point 6 shows the direction of the foliation/schistosity of the ground. The shot was taken in 2008.

The flake at the point no 3 in Figure 8 has been detached later than 1974. The two cracks at the right roof slab have also been formed after year 1974. Both the flake detachment and the cracks, were determined to have occurred after 1974 following comparison of a 1974 picture (DAI 74-2202 in Kienast, 1995) with a current one (2008).

Such an evidence found at a 2,6 thousand -year old monument can be considered as very rare. The spalling observed shows that the surrounding ground still stresses the masonry wall. In general it is also obvious that the west side of the wall is more distressed.

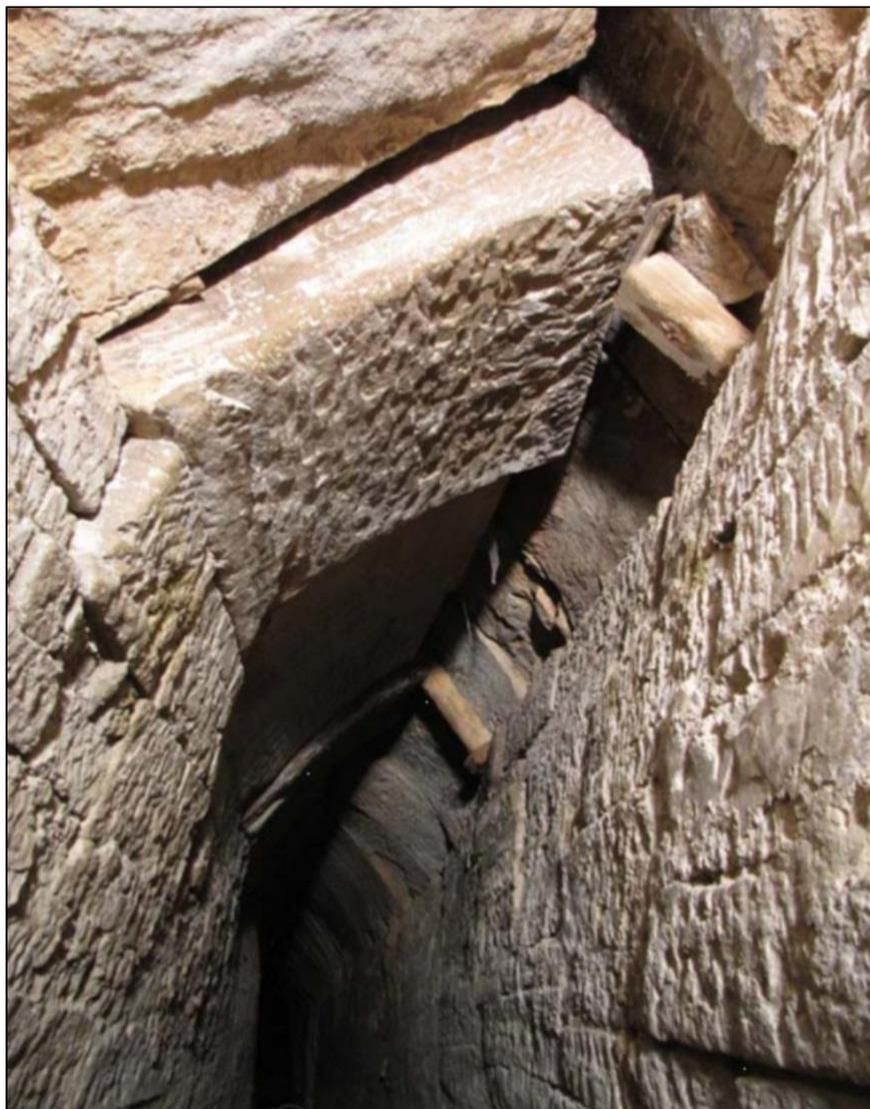
From **ch 0+130** to **ch 0+136** the wall is highly deformed and the arched stones of the roof are displaced and fractured (Figure 13).

Fig. 13: The tunnel at ch. 0+130 with dislocated roof stones.

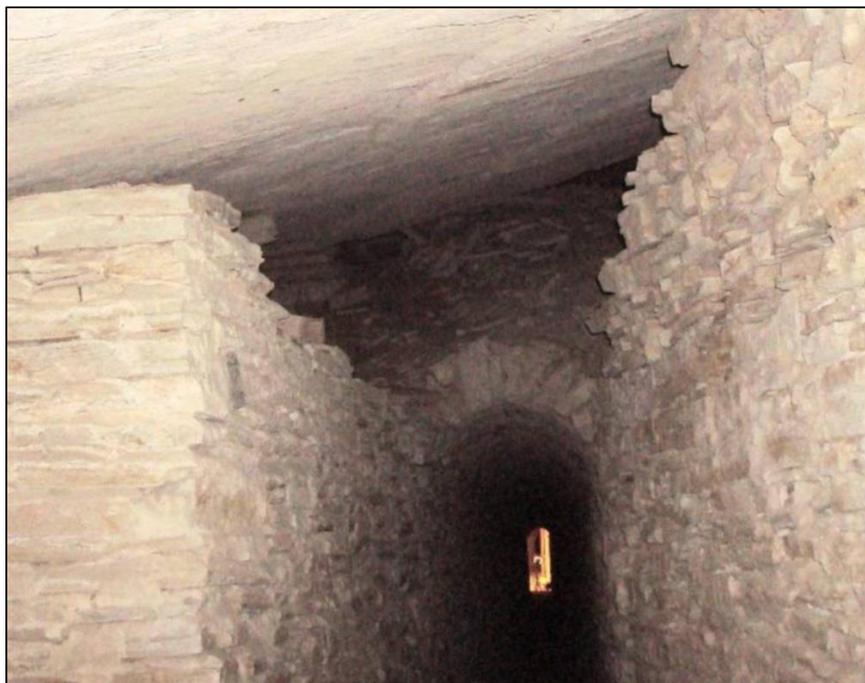
Fig. 17: Roman type wall of the north portal. The tunnel roof (geological bedding is subparallel to the tunnel axis) has collapsed on the arch of the wall. For a limited length the walls are vertical up to the tunnel roof.

The rock mass here consists of thinly bedded limestone with sub horizontal bedding. The excavation geometry above the lining is visible from **ch 0+011** (Figure 17). The tunnel roof has been gradually collapsing. Most likely this explains why this section was protected in the Roman era. Today, the arched roof is loaded with the weight of the debris that has fallen on it; when this weight became excessive the roof subsided and slipped (Figure 18).

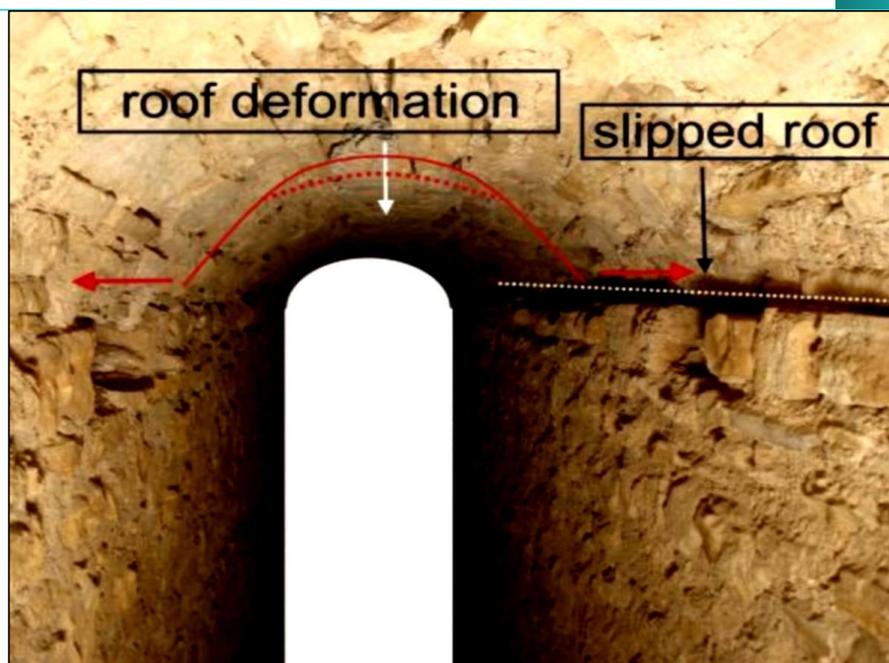
Fig. 18: Arched roof slipped and deformed

Here, the thicknesses measured by GPR are in good agreement with the actual width (25 to 30 cm) of the stones of the masonry wall. On the other hand the measured ERT thickness at the opposite sidewall is in good agreement with the sum of the actual thickness of the lining plus the thickness of the possible backfill.

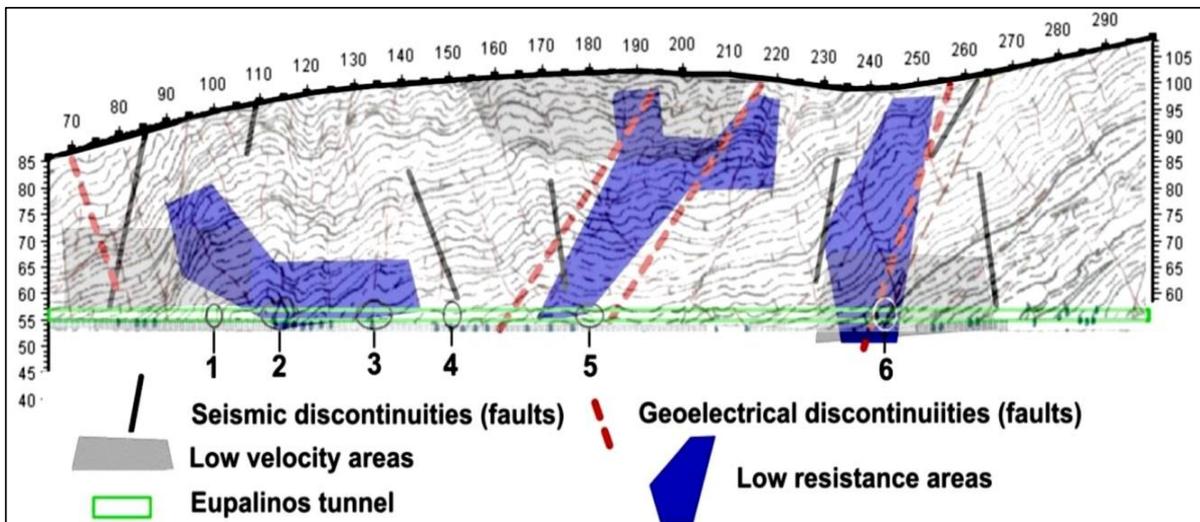
The evaluated geophysical results are in good agreement with those of the geological mapping. The geophysical methods have identified the distribution of the major fault zones in the ground. They have also supplemented the geological mapping observations at the level of the tunnel, by recognizing, the areas of a poor/low strength ground adjacent to the faults. For example, the area of the intersecting faults from **ch 0+090** to **0+140** that was identified with the geological mapping at the surface was also identified (as a low resistance area) at the tunnel levels by the geophysical methods. It is of great interest that the damages identified at the tunnel masonry walls are located at the intersections of the tunnel with the fault zones mentioned earlier. Most of them occurred between **ch 0+090** to **0+140**. For example, a serious damage at the wall (Figure 20) at chainage **0+180** is located at the intersection with a major fault zone.

Fig. 19: Geophysical and geological longitudinal section along the lined (protected) tunnel section at the north bore (Tsokas et al, 2014). Damage on the wall: **1:0+100**, **2:0+110-0+117**, **3:0+130-0+136**, **4:0+149**, **5:0+178-0+184**, **6:0+245**.

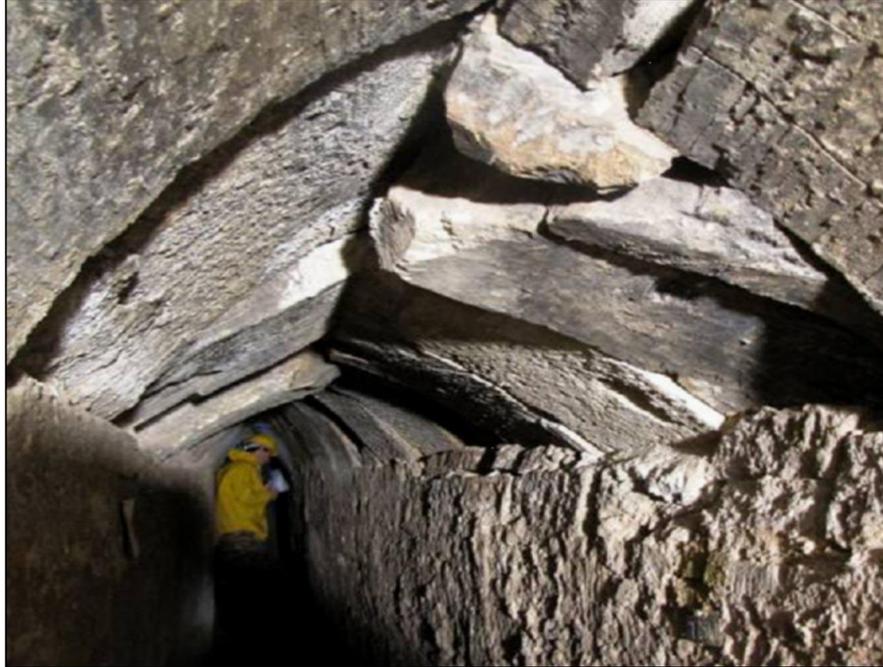
Fig. 20: Fractured and displaced arched stones at chainage 0+180.

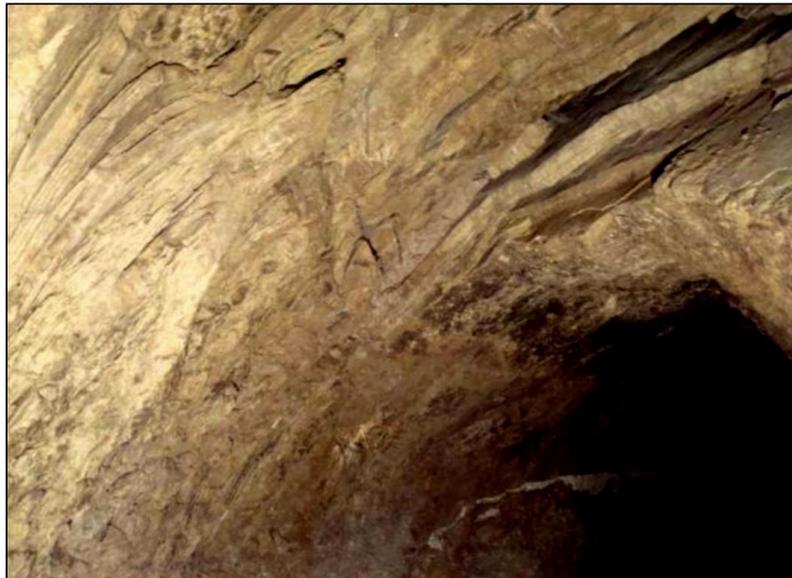
Fig. 21: Thinly bedded marls, green schistose clays (some slippage of rock material has occurred along a planar joint to the right).

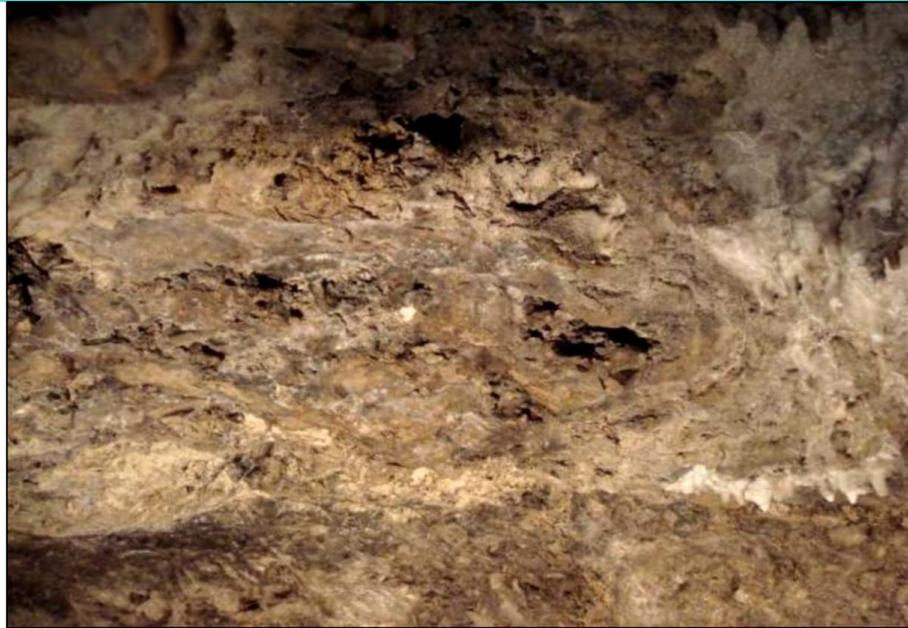
As mentioned in the previous paragraph, the ground behind the walls comprises thinly bedded marls and green schistose clays. These (when sheared and faulted) form an amorphous soft clayey matrix with rock fragments (Figures 21 and 22).

Fig. 22: Amorphous soft clayey matrix with rock fragments near the start of the first part of the Archaic wall.

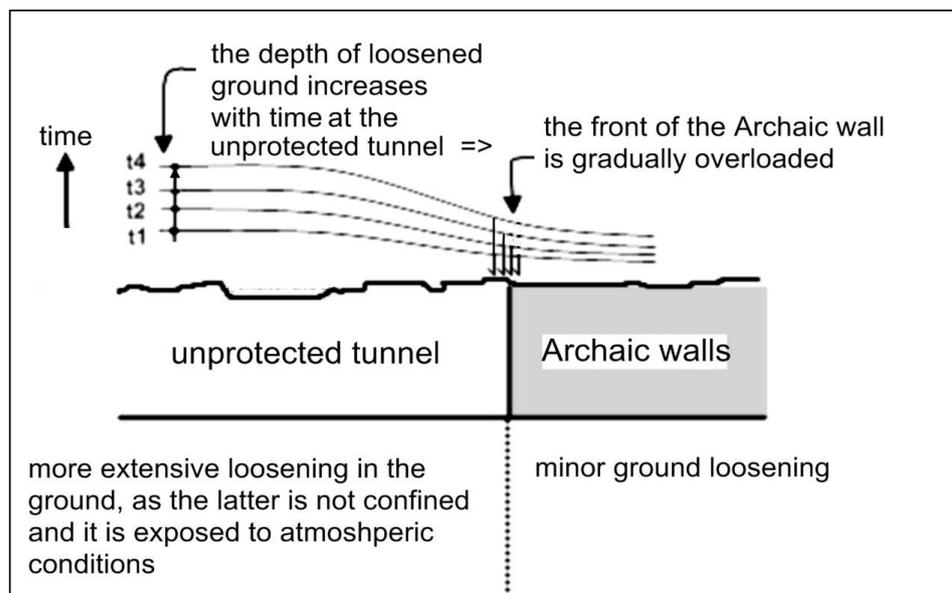
Considering also the results of the previous investigations, a simplified analysis was carried out in order to investigate the minor on-going fracturing (spalling) occurring at the front view of the Archaic wall at ch 0+63,9. This analysis was performed using the finite element code Phase 2 (www.rocscience.com). At this point, the wall has to bear the increasing weight of the gradually loosening rock mass. Loosening of the ground is a time dependent process that happens due to the deterioration of the ground (as it is exposed to variations in moisture, drying, temperatures). When the stresses induced in the stone blocks of the wall exceed their strength, the latter gradually fail (spalling). This process is illustrated in Figure 23.

Fig. 23: Longitudinal section of the tunnel. Hypothesis to explain the minor failures (spalling) of the Archaic wall front.

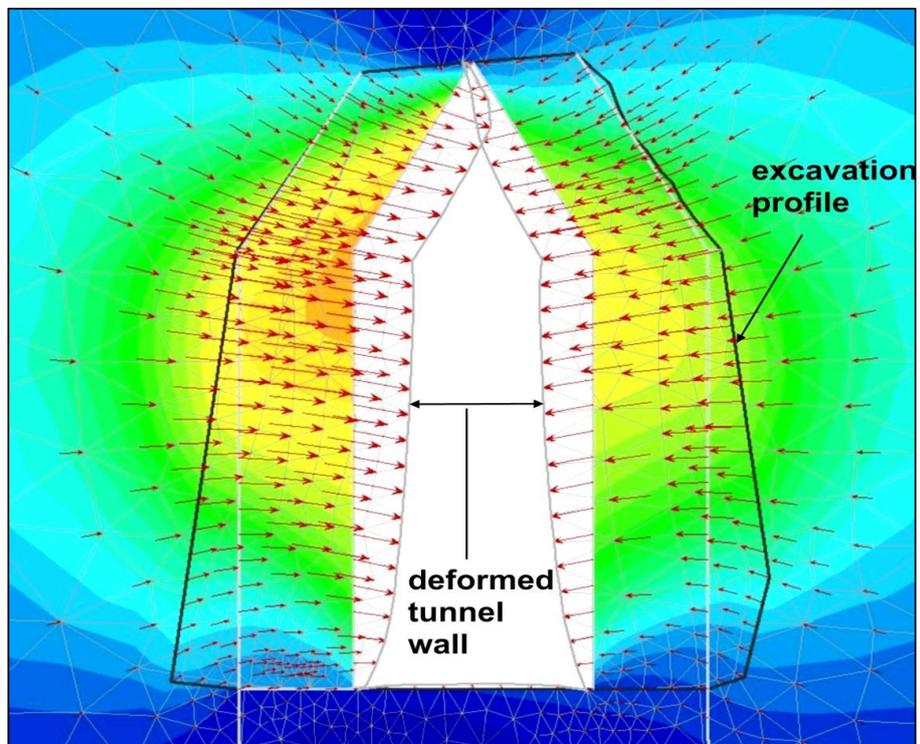
A simplified finite element analysis was also carried out in order to understand the failure pattern of the wall's roof of chainage **0+130** (Figure 13). The west stone block is significantly dislocated and is temporarily supported by a wooden wedge. The ground is simulated as a homogenous material with low strength properties. The pattern of the calculated deformation is shown in Figure 25. The deformation magnitude is similar to both sides of the wall (the maximum measured deformation is 5 cm).

Fig. 25: Finite element analysis results. Deformation analysis of the wall at ch. 0+130.

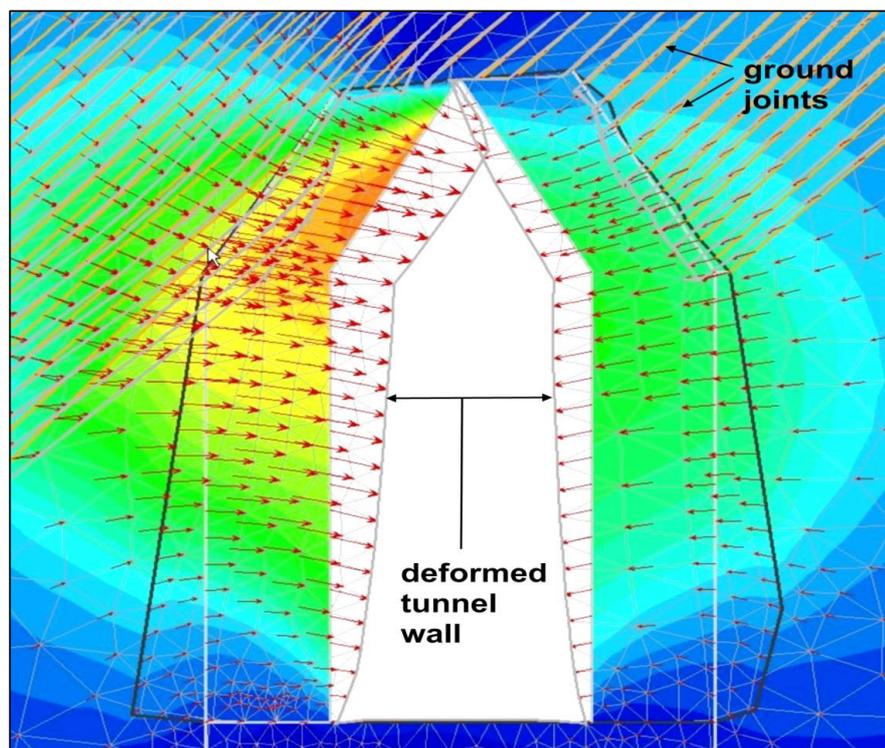
Fig. 26: Finite element analysis results. Deformation analysis of the wall at ch. 0+130. Joints have been introduced in the ground.

In this case, despite the fact that the deformation of the east wall remains the same, the deformation of the west wall is doubled; this explains both the real wall condition and to a certain extent the magnitude of the real deformation. The results of this simplified analysis show the possible impact the orientation of the joints in the ground may have on the failure pattern of the wall. It is impossible to estimate the time this damage occurred or what has been its real mechanism. It is most likely that the ground load was imposed gradually on the wall. Creep in the ground, excessive water pressures, swelling pressures due to minerals at fault gauge, seismic shocks, may have all contributed to some degree to the wall failure. In addition, when the contact of the two stone blocks of the roof was eventually lost, the stones slipped inwards. Then the ground behind the stone blocks was further relaxed and loosened and additional loads were imposed on the wall.

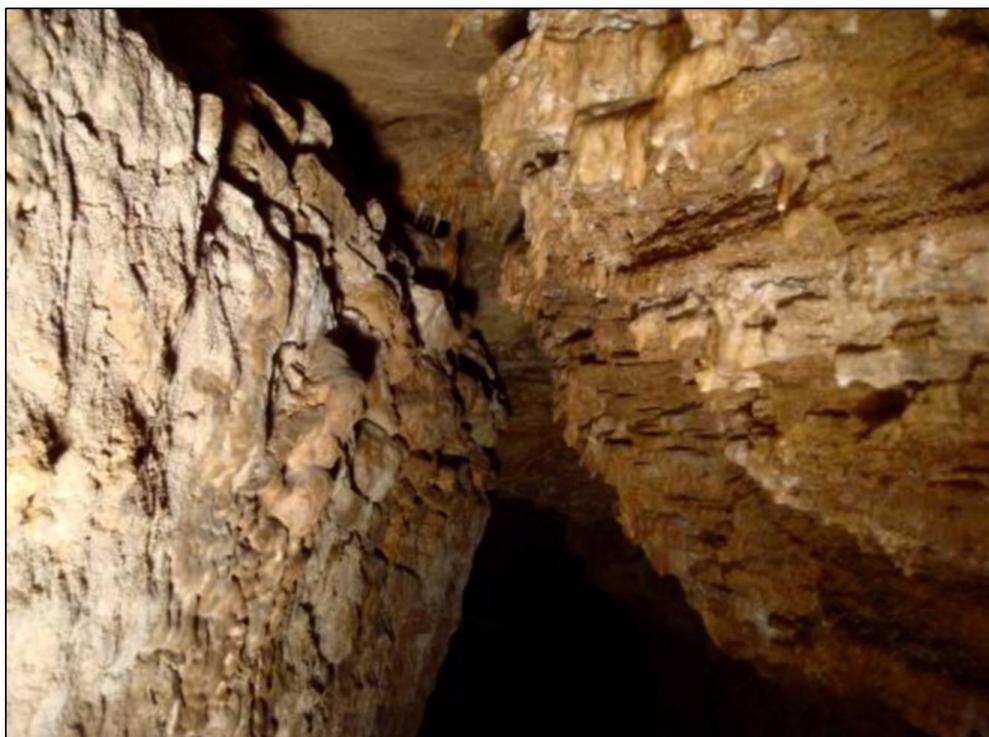
Fig. 31: Ground collapse $>1,5$ m located between the Archaic wall sections from 0+230 – 0+240.
