The Walls of Eupalinos Aqueduct, Samos Island, Greece. Description, Pathology and Proposed Restoration Measures

*Research Paper*

THE WALLS OF EUPALINOS AQUEDUCT, SAMOS ISLAND, GREECE. DESCRIPTION, PATHOLOGY AND PROPOSED RESTORATION MEASURES

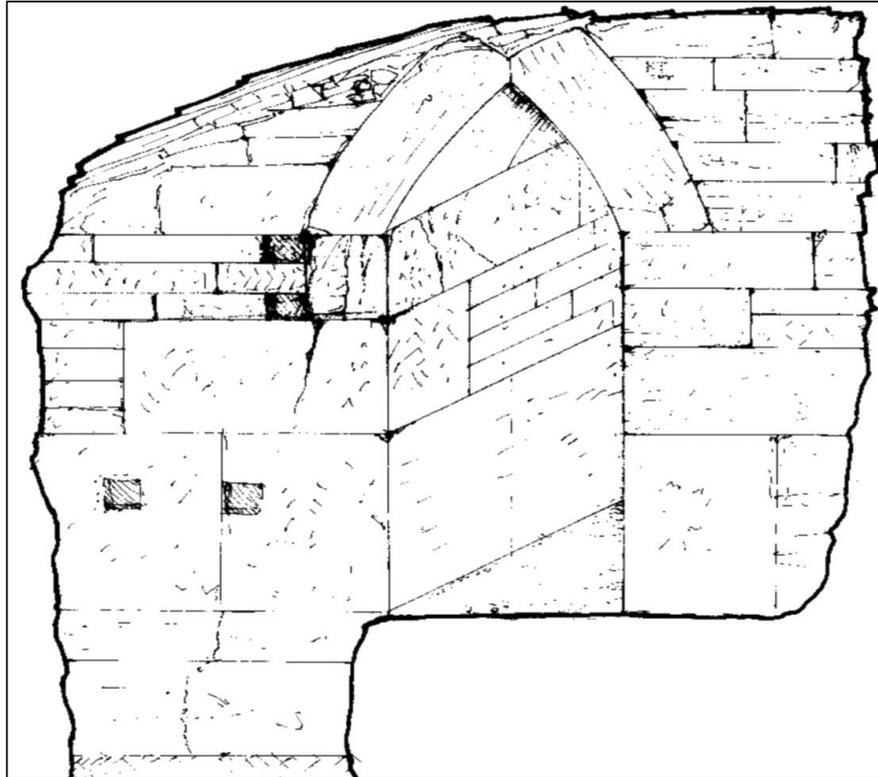
~70 cm wide and 1,70 m high. Further inside, the wall's sides are made of stones with completely different dimensions. They are 8 to 12 cm thick also non mortared; their edges have been so meticulously treated, placed and adjusted that practically all joints are in full contact. Therefore, the stability of the wall results from the high hewing quality of its building stones and their subsequent tight placement and fixing works.

Fig. 2: View of the Archaic wall at ch 0+064.

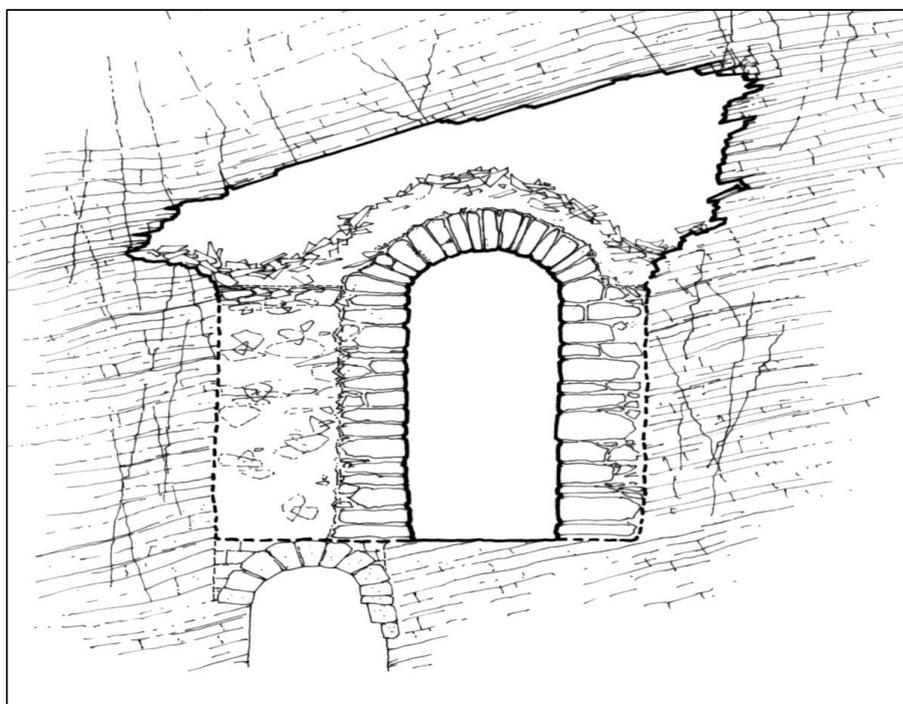
The Roman lining at the north tunnel portal starts at ch. 0+014 and ends at ch 0+049 (35 m). It is made with a mortared masonry wall and an arched roof. The thickness of the mortared joints is ~3 cm, while the stone bricks of the vault are ~15 cm thick. The roof's arch, diligently constructed, has a height of 25 to 35 cm. Figure 3 shows a cross section of the lining's walls (at the north portal) built in the Roman era. A Roman-type wall also supports the sides and the roof of the trench. The horizontal clearance of the passageway is almost 0,60 m and the vertical is 1,60 m. Here, the orientation of the geological bedding is unfavorable for the stability of the tunnel's roof, which gradually collapsed on the vault.

Fig. 3: Cross section of the main tunnel at the north portal showing the Roman type protective walls.

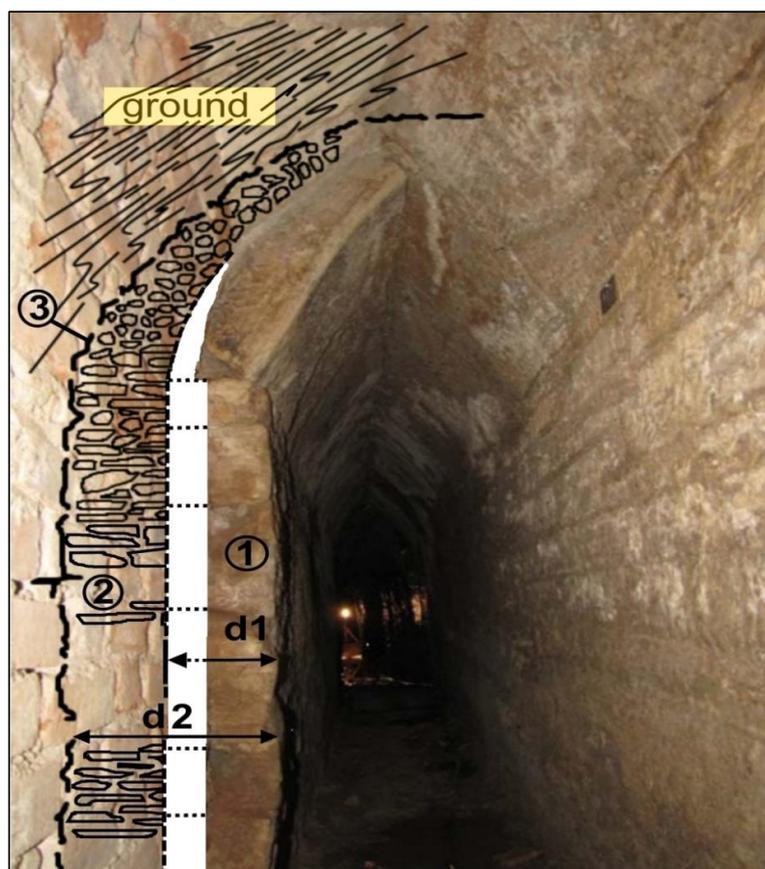
Fig. 4: Photograph of the reconstructed west sidewall (mortared masonry at the left hand side of the picture). The drawing overlay is a simplified representation of the space behind the walls.

The overlay in Figure 4 shows the structure of the tunnel behind the wall as this was revealed during the reconstruction works. Area 1 represents the wall. The dimension “d1” is the thickness of the hewn stones of the deformed wall. The most important finding from an engineering viewpoint has been the presence of backfill material in the space between the lining and the excavation (area 2). The backfill was made up of well-stacked but poorly worked hewn stones. The backfill material is extended upwards over the arched stones of the roof. This backfilling serve an important engineering purpose: to confine the excavation and eliminate the conditions which could lead to a ground collapse behind the lining. The dimension “d2” thickens “d1” plus the thickness of the backfill material. Line 3 shows the ground-backfill interface. For comparison purposes only, the previously mentioned basic dimensions of the tunnel are also shown in Figure 5, a cross section of the walls of the south tunnel portal.

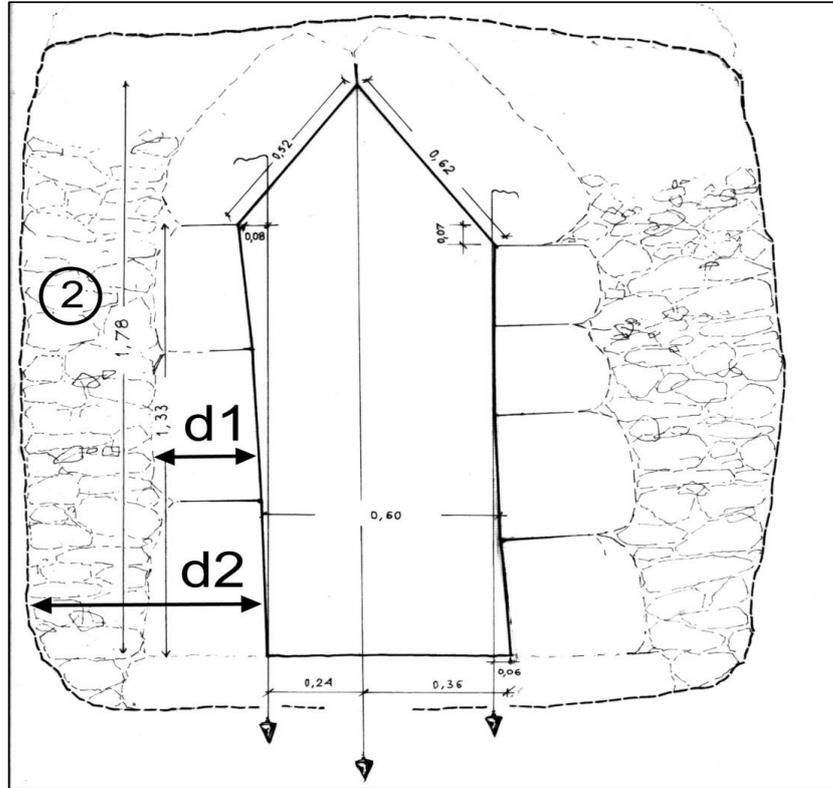
Fig. 5: Basic dimensions of the tunnel (walls at south tunnel portal). “d1” is the thickness of the hewn stones of the wall. “d2” is the sum of the thickness “d1” plus the thickness of the backfill material (area 2).

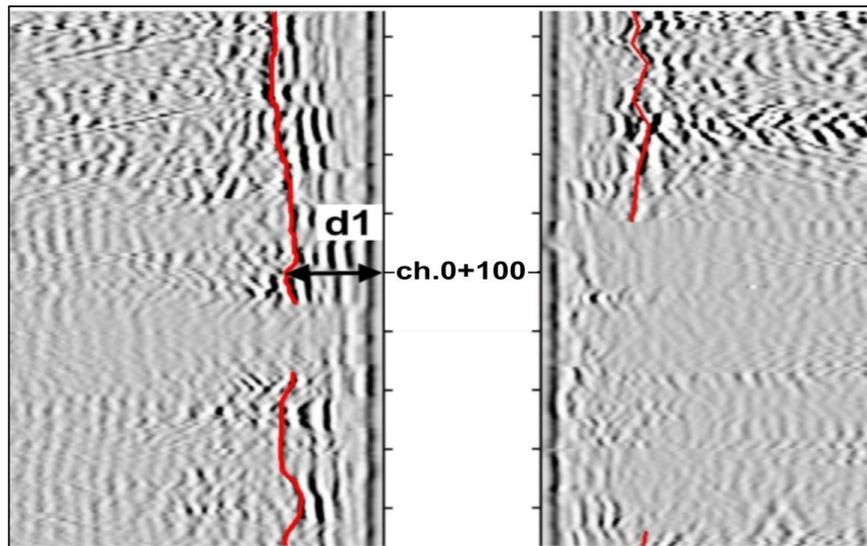
The wall was investigated by means of ground penetration radar (GPR) and electrical resistivity tomography (ERT). The evaluation of the GPR results is shown in Figure 6. It is obvious that the GPR method predicts the wall – backfill interface or in other words the thickness “d1” of the wall’s hewn stones. The actual thickness of the wall “d1” is almost 25 cm (Figure 5). It is practically identical with the one derived from the interpretation of the GPR results, dimension “d1” at Figure 6.

Fig. 6: Results of ground penetration at ch. 0+100.

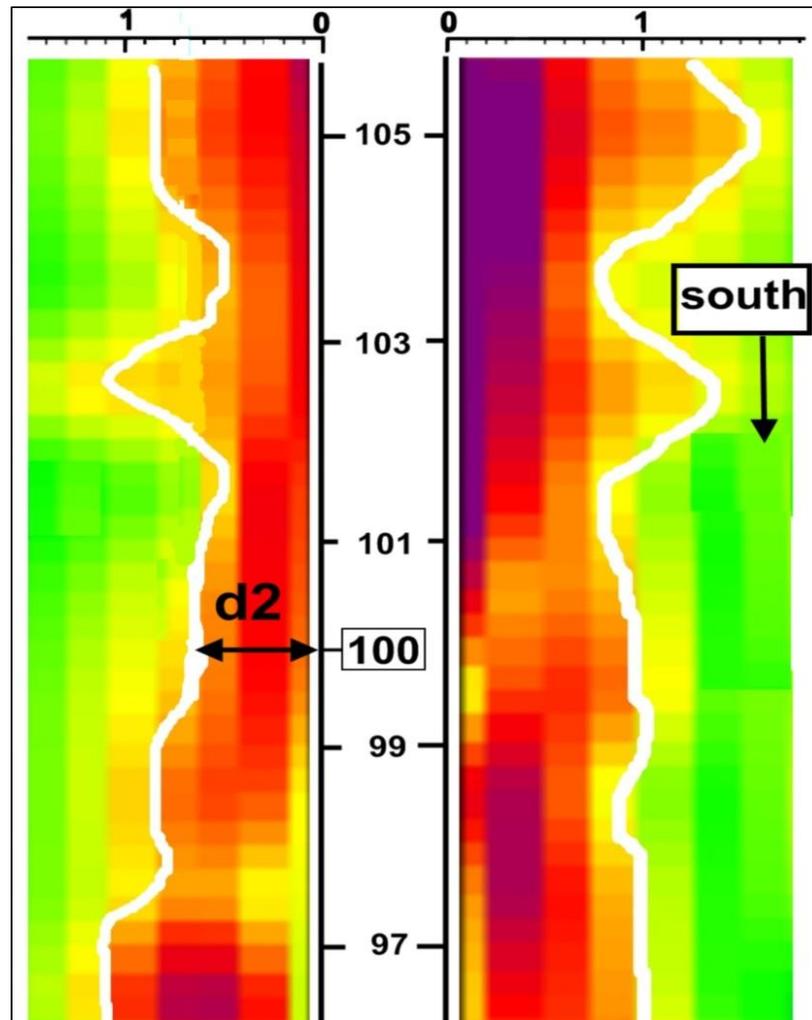
On the other hand, the ERT method predicts (Figure 7) the ground – backfill interfaces or in other words the sum of the thickness of the wall’s hewn stones “d1” plus the thickness of the backfill material. The actual thickness “d2” is almost 60 cm (Figure 5). It is practically identical with the one derived from the interpretation of the ERT results, dimension “d2” at Figure 7. GPR signal loss (no rebound measured), at approximately **ch 0+100** is justified by the high-water content that is observed in this area.

Fig. 7: Electrical resistivity results at ch. 0+100. High resistivity boundaries (white lines) match with the ground – backfill interface boundary.

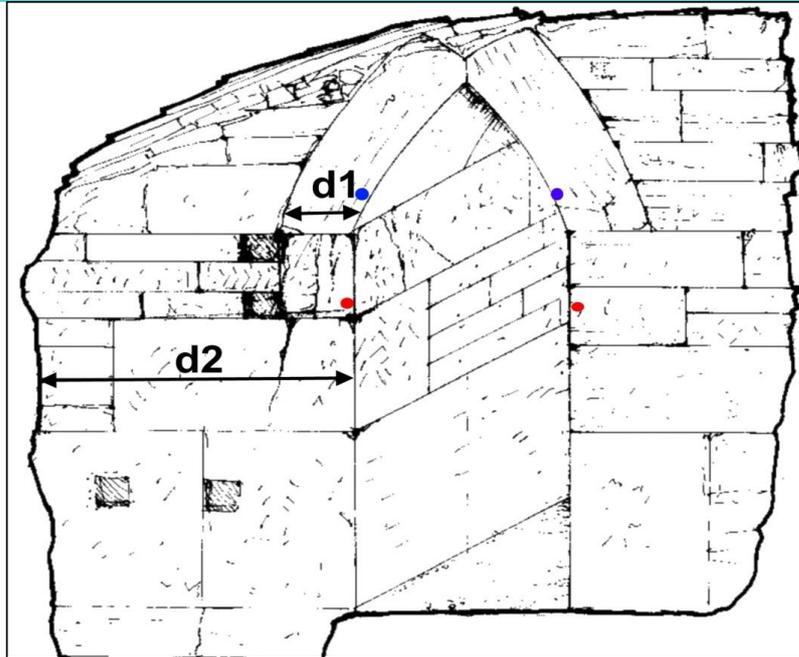
The thickness of the wall that starts from chainage **0+064** and further inside has been investigated by means of ground penetration radar (GPR) and electrical resistivity tomography (ERT). Figure 9 shows the basic dimensions “d1” and “d2”. Blue and red dots show the levels of the GPR and ERT scan lines.

Fig. 9: Sketch of the tunnel wall of ch. 0+064. Blue and red dots show the levels of the GPR and ET scan lines.

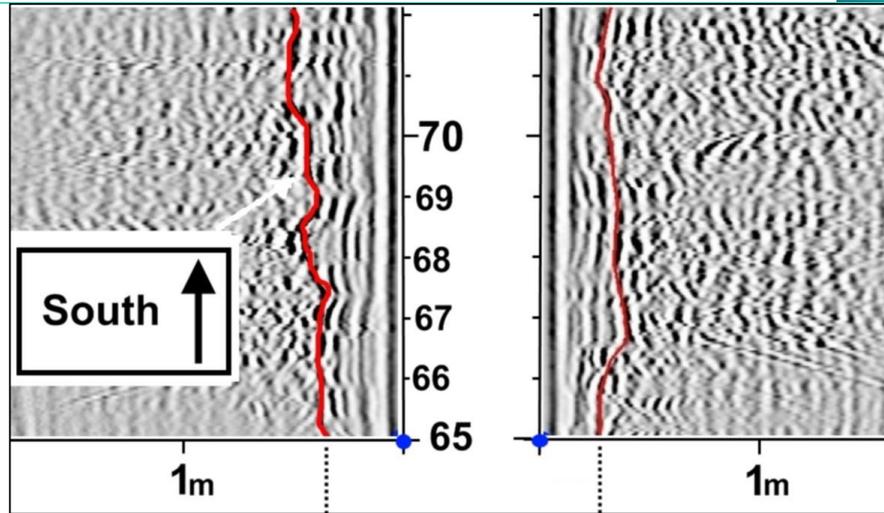
Figures 10 and 11 show the results of the GPR. Figure 12 shows the ERT result at the west sidewall of the lining (at the level of the point). The comparison of the GPR results shows again that this method practically predicts the thickness of the solid hewn stones of the walls (backfill-wall interface).

Fig. 10: Results of ground penetration radar at ch 0+64 at the level of the blue point. The graph shows the results from a 6-7 m long section of the tunnel’s lining to the South (from ch 0+064 to 0+072). The red line shows the thickness of the wall’s hewn stones.

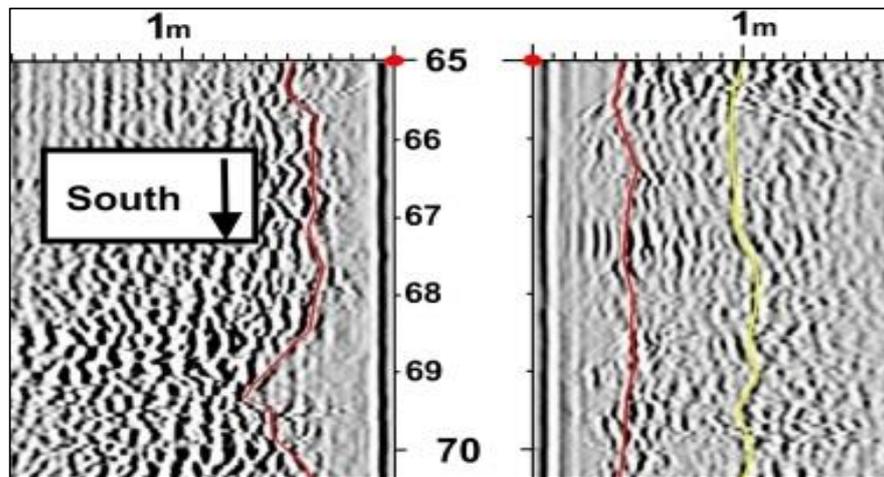
Fig. 11: Results of ground penetration radar at ch 0+63,9. The yellow line is most probably a significant joint or a fault running parallel to the tunnel.

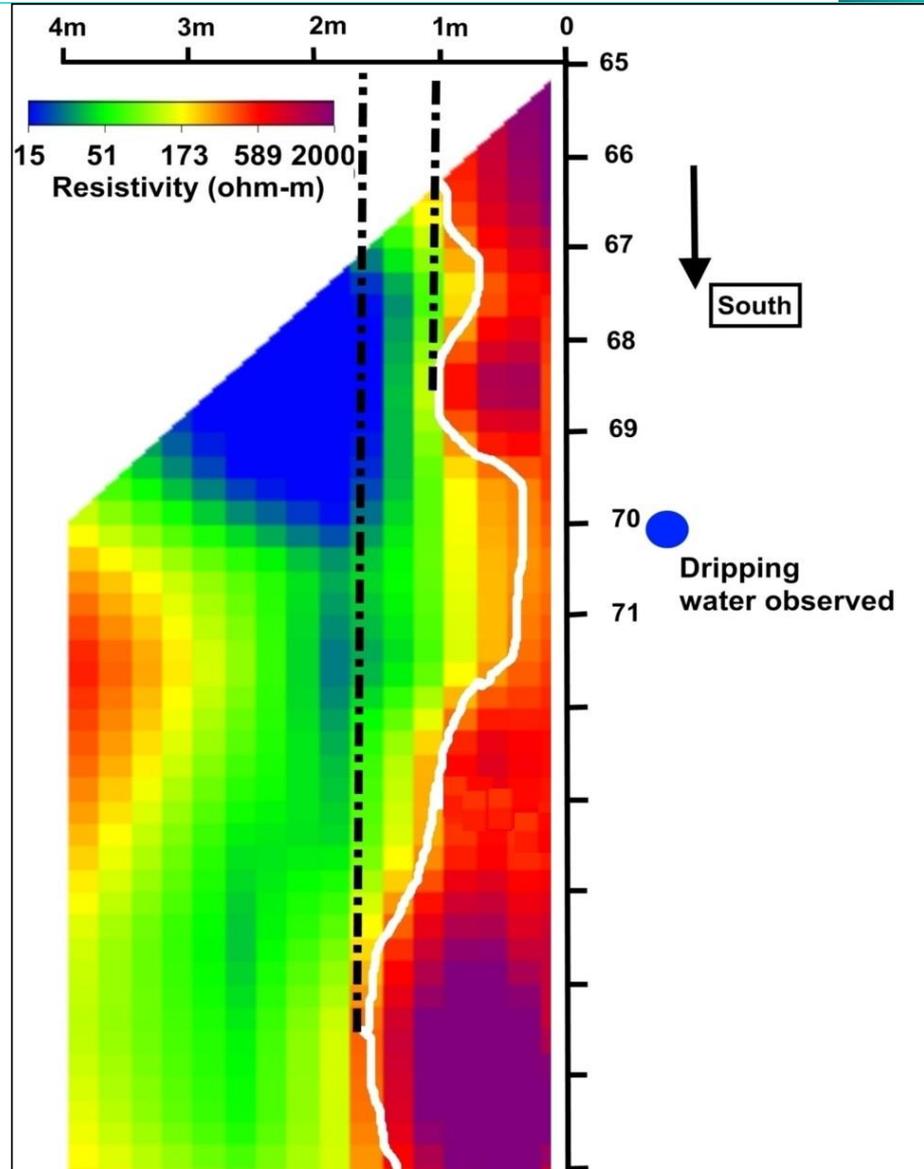
The ERT method on the other hand estimates well the dimensions of the excavation profile (backfill-ground interface). An area with very low resistivity (blue area) at ch **0+070** has also been evaluated as an area with high water content. Dripping water is observed in this location.

Fig. 12: Results of electrical resistivity tomography near ch 0+64 at the west sidewall of the lining. The white line represents the ground-backfill interface. The line that represents the interface is very uneven most likely due to the ground collapses that occurred during the tunnel drive.

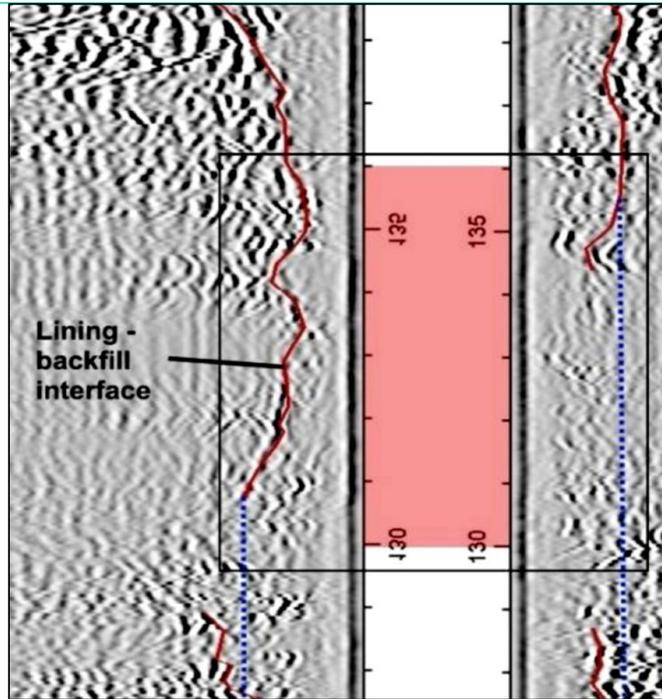
Figure 14 shows the GPR results and Figures 15 and 16 the ERT results. Electrical resistivity tomography has been used along four lines of the wall (two at either side). The lower ones were at 0,6 m from the walking level and the higher 1,10 m from the walking level.

Fig. 14: Results of GPR. The red line represents the hewn stones – backfill interface.

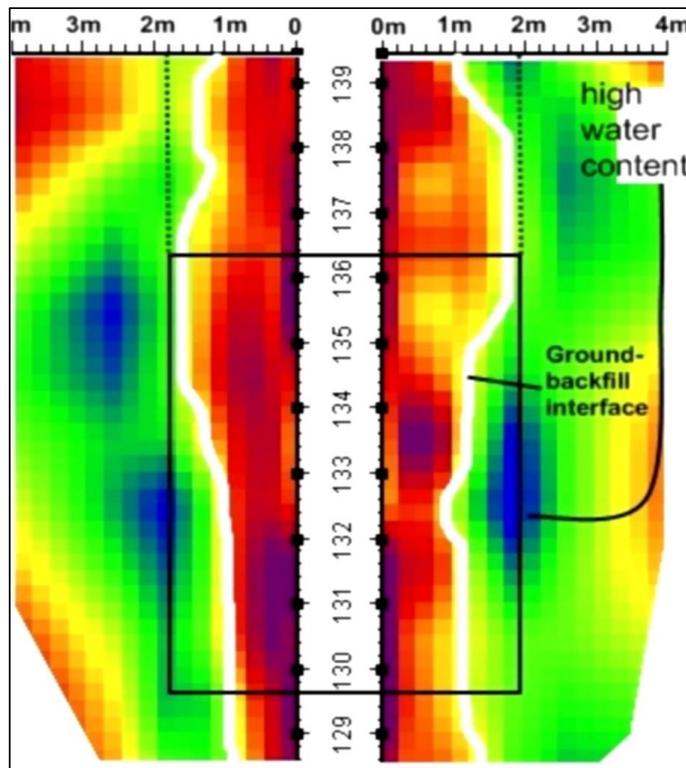
Fig. 15: Results of ERT 1,10 m above the walking level.

The pattern of the wall here is the same as the one described previously. The maximum wall thickness (solid rock blocks) is 50 cm, observed at **ch 0+131** at the west side. The ERT results are very striking. At level 1,10 m the excavation width (white line) is the maximum identified. It reaches 2 m on either side. Interesting is the fact that at level 0,60 m the excavation width reduces down to less than 1m. This can be explained by the presence of a cave-in (ground collapse) that occurred during excavation and enlarged both sidewalls. Areas of high water content are present on either side of the tunnel.

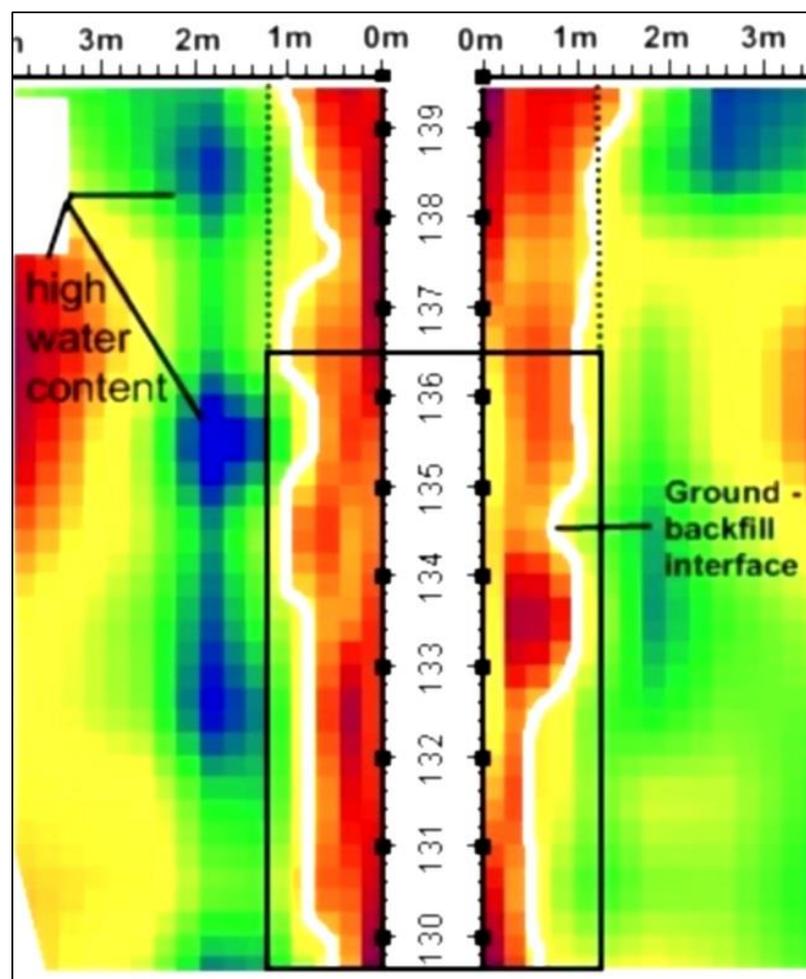
Fig. 16: Results of ERT at 0,60 m above the walking level.

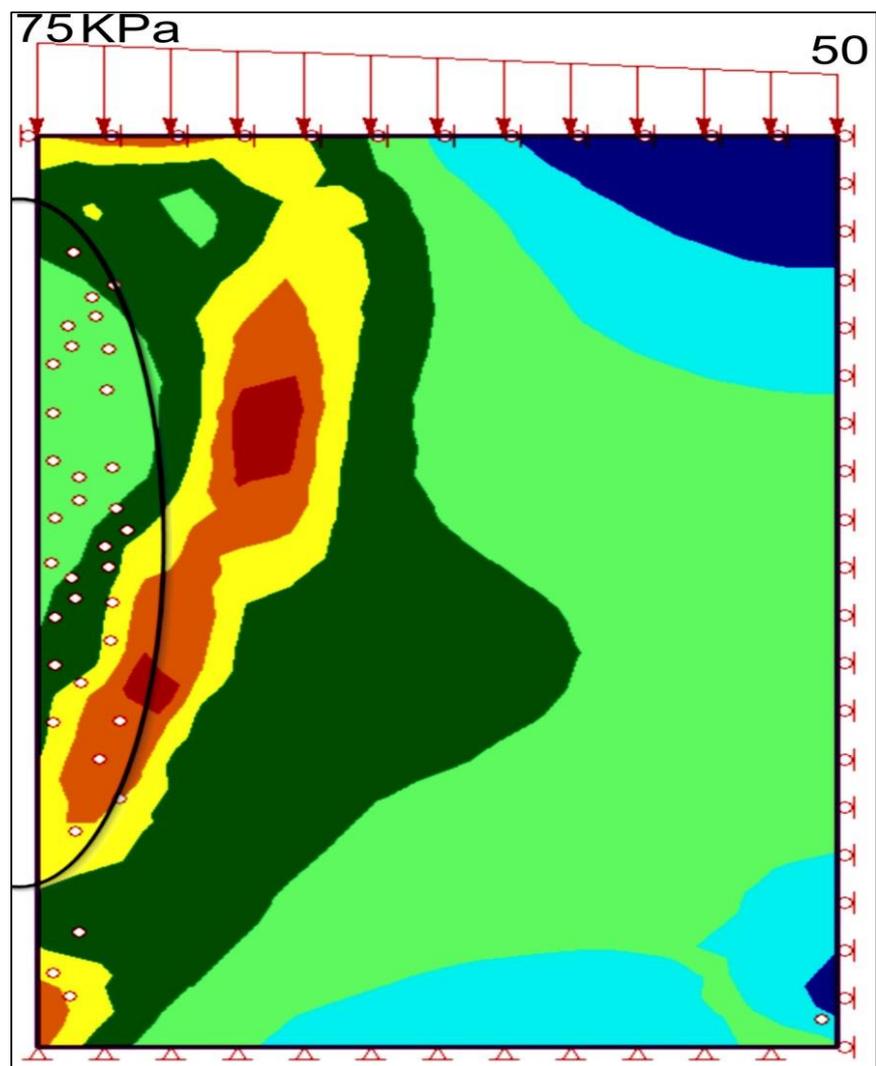
The possible stress – strain distribution of the stone blocks of the roof has been investigated with the use of a simplified stress analysis. The strength parameters selected for the stone are 1,0 GPa for the modulus of elasticity, 3,0 MPa for the cohesion and 45° for the angle of shear resistance. An axisymmetric trapezoidal load distribution was applied to the top edge of the stone. The larger load (75 KPa) is at the side of the stone towards the unprotected tunnel section. The smaller load (50 KPa) is

towards the walled tunnel section (see Figure 8). At the top edge of the stones and due to the frictional forces between the first and the ground, only vertical movement was allowed in the modeling. The vertical movement was allowed at the vertical edge of the stone. The base of the stone was assumed to be fixed. Figure 24 shows the shear strain distribution of the stone. The hot colors represent areas of higher strain. The white circles are points within the stone, where tension failure occurs. The strain distribution and the shape of the area that fails in tension can explain the spalling observed (Figure 8).

Fig. 24: Finite element analysis results. Shear strain distribution in the hewn stone.

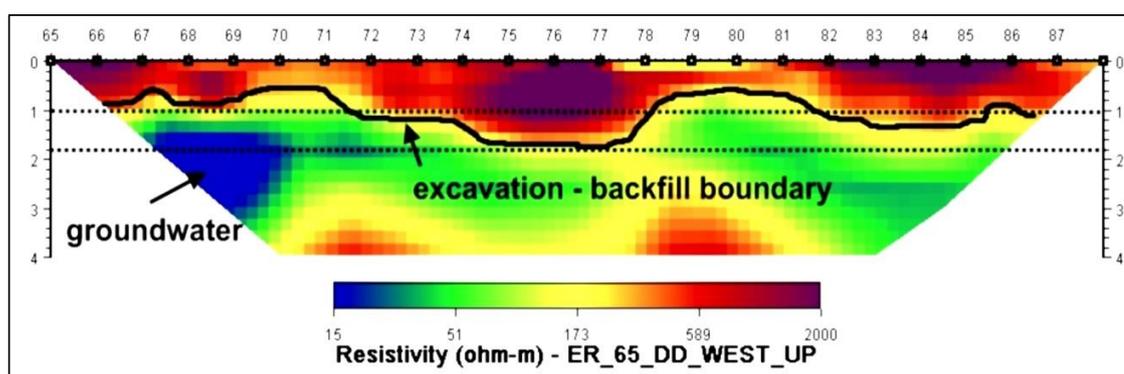
Fig. 30: Variation of the west side excavation geometry along a line located 1,10 m above the walking level. The maximum excavation width is almost 2 m at the west side. The lower is almost 0,6 m.
